DOT/FAA/CT-94/116

# Vertical Drop Test of a Narrow-Body Fuselage Section with Overhead Stowage Bins and Auxiliary Fuel Tank on Board

April 1995

Final Report

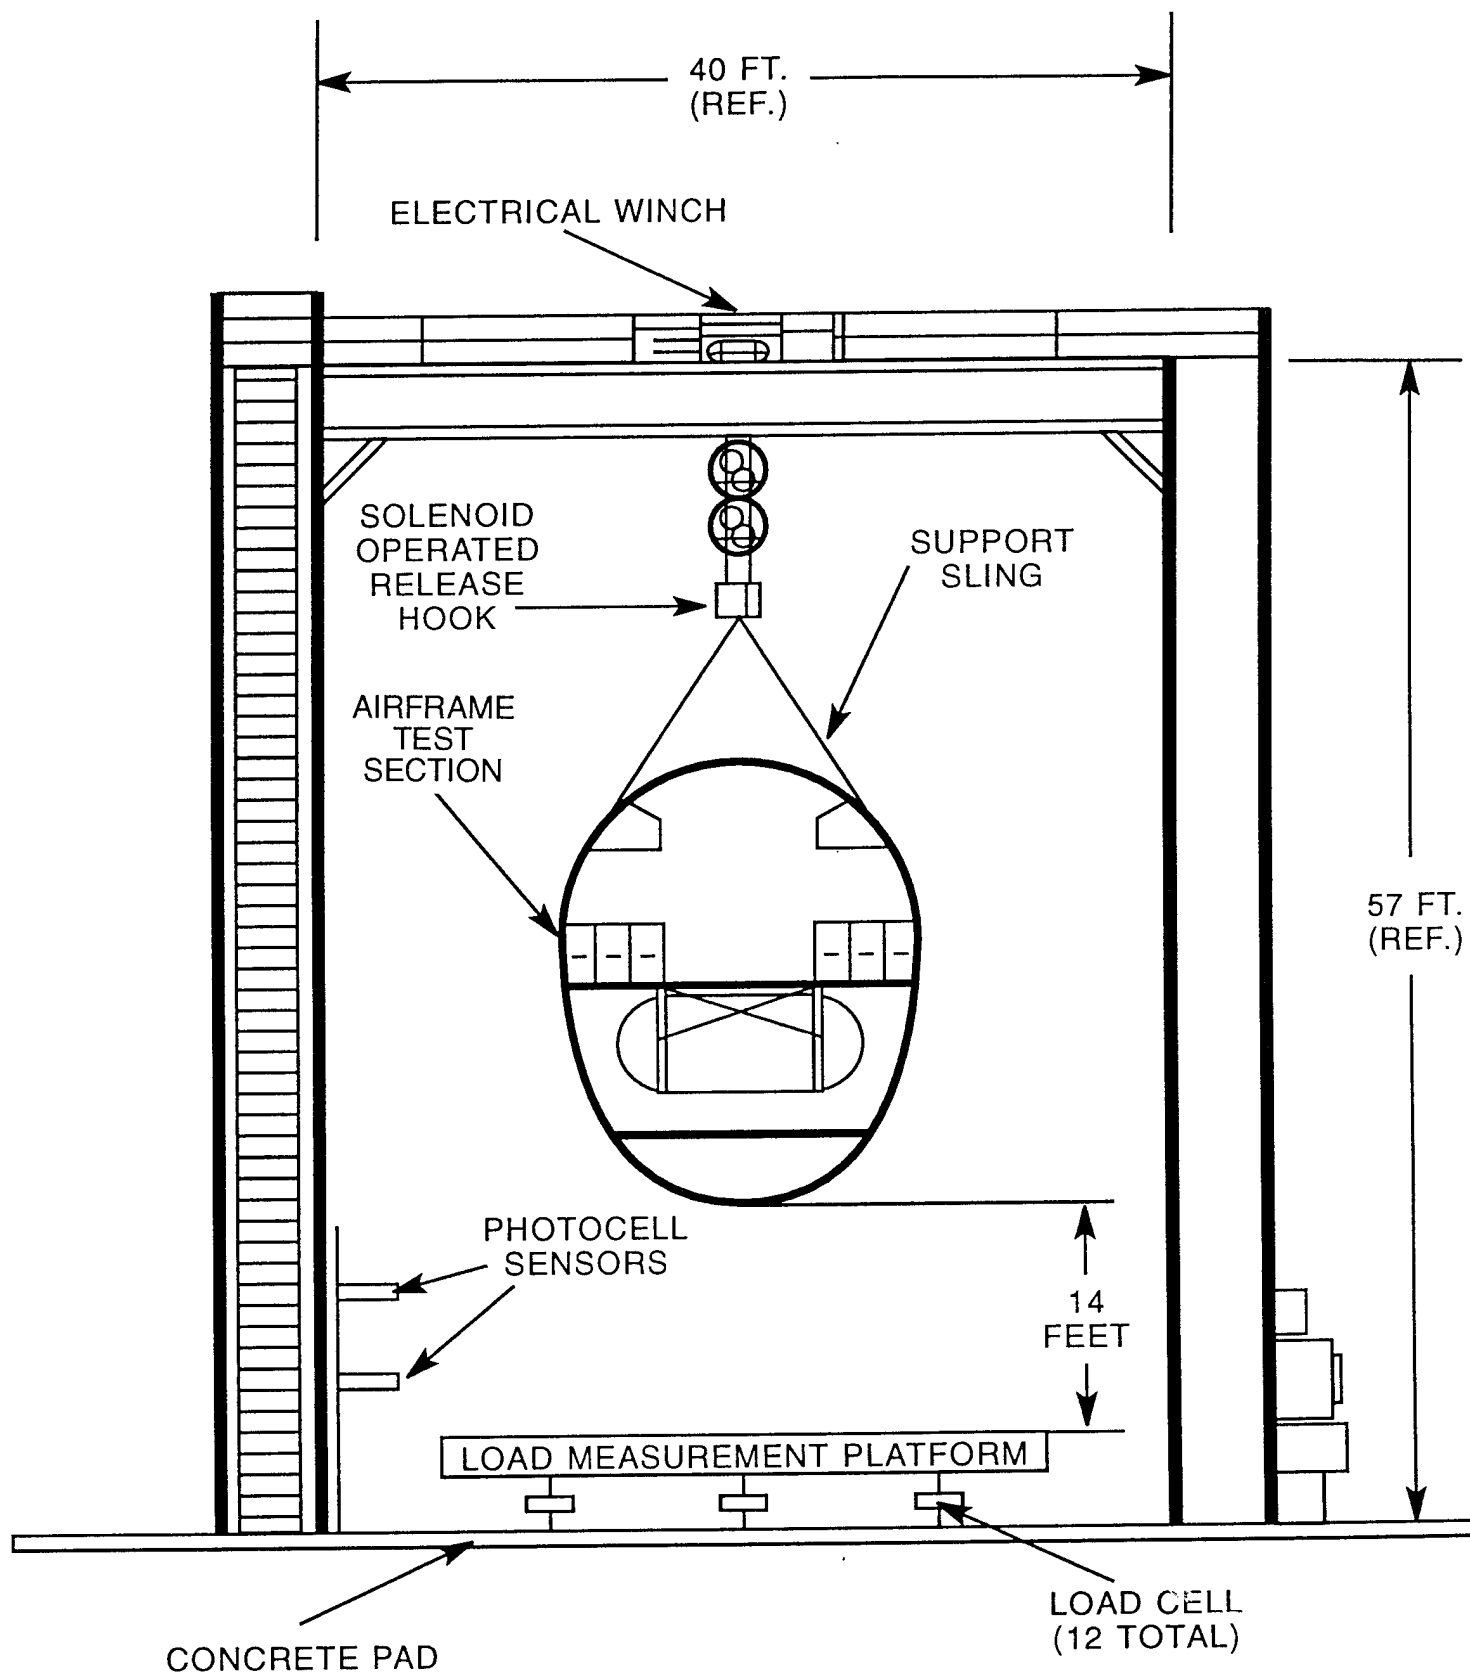
FIGURE 1. DROP TEST FACILITY

The Technical Center drop test facility (figure 1) is comprised of two 50-foot vertical steel towers connected at the tops by a horizontal platform. An electrically powered winch, mounted on the platform, is used to raise or lower the test article and is controlled from the base of one of the tower legs. The lifting capacity of the winch is rated at 13,600 pounds. Attached to the winch is a reeved hoisting cable which is used to raise the test article. A sheave block assembly hanging from the free end of the reeved cable is engaged to a solenoid operated release hook. The release hook is connected to the airframe by a cable/turnbuckle assembly with hooks bolted to the fuselage section at four locations. Located below the winch cable assembly and between the tower legs is a 15- by 36-foot wooden platform which rests upon I-beams and is supported by 12 independent load cells.

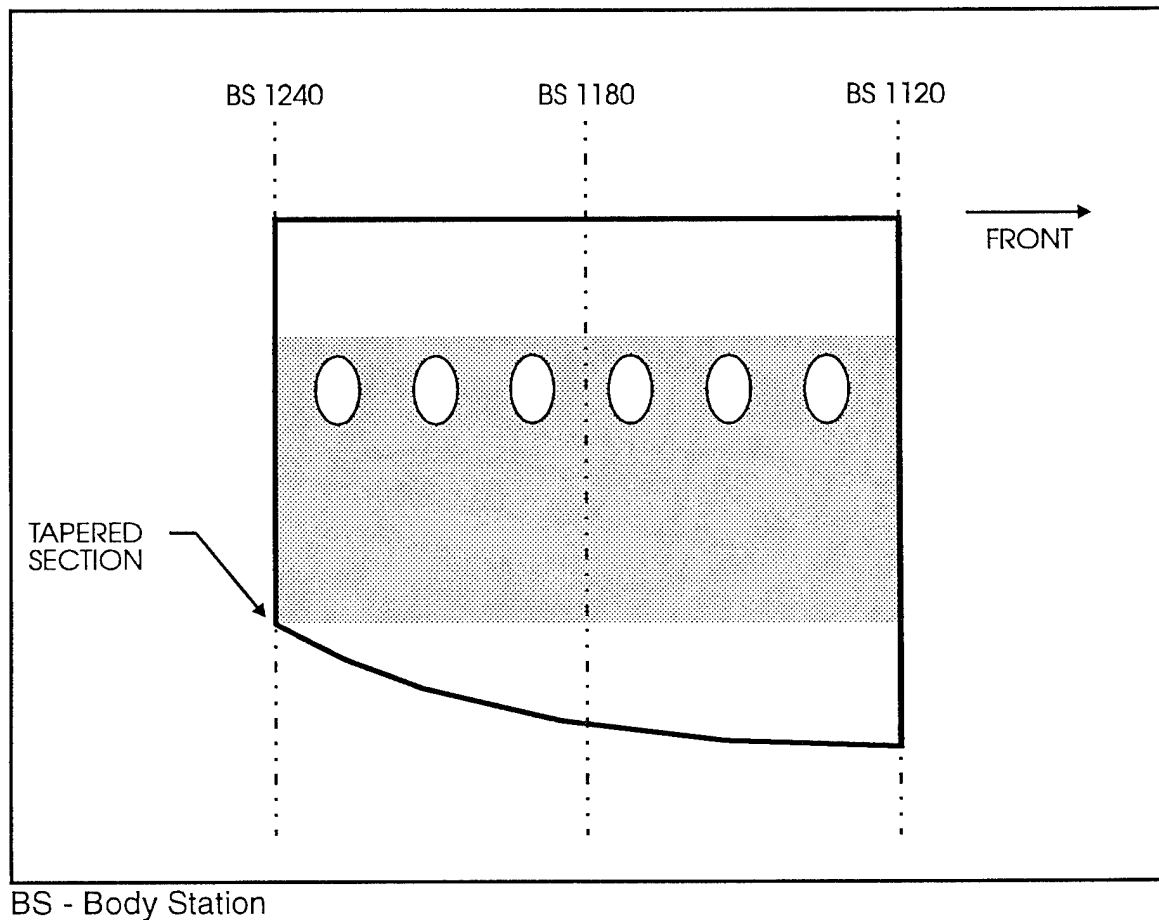
FIGURE 2. TEST SECTION, SIDE VIEW

The test article was a ten-foot tapered section of a Boeing 707 cut from body station (BS) 1120 to 1240 (figure 2). The section was equipped with seats, overhead bins, and an auxiliary fuel tank system. The outer floor beams at each end of the section were reinforced to minimize the open end effects, i.e., to simulate the reaction that would be seen if an entire aircraft fuselage was tested.

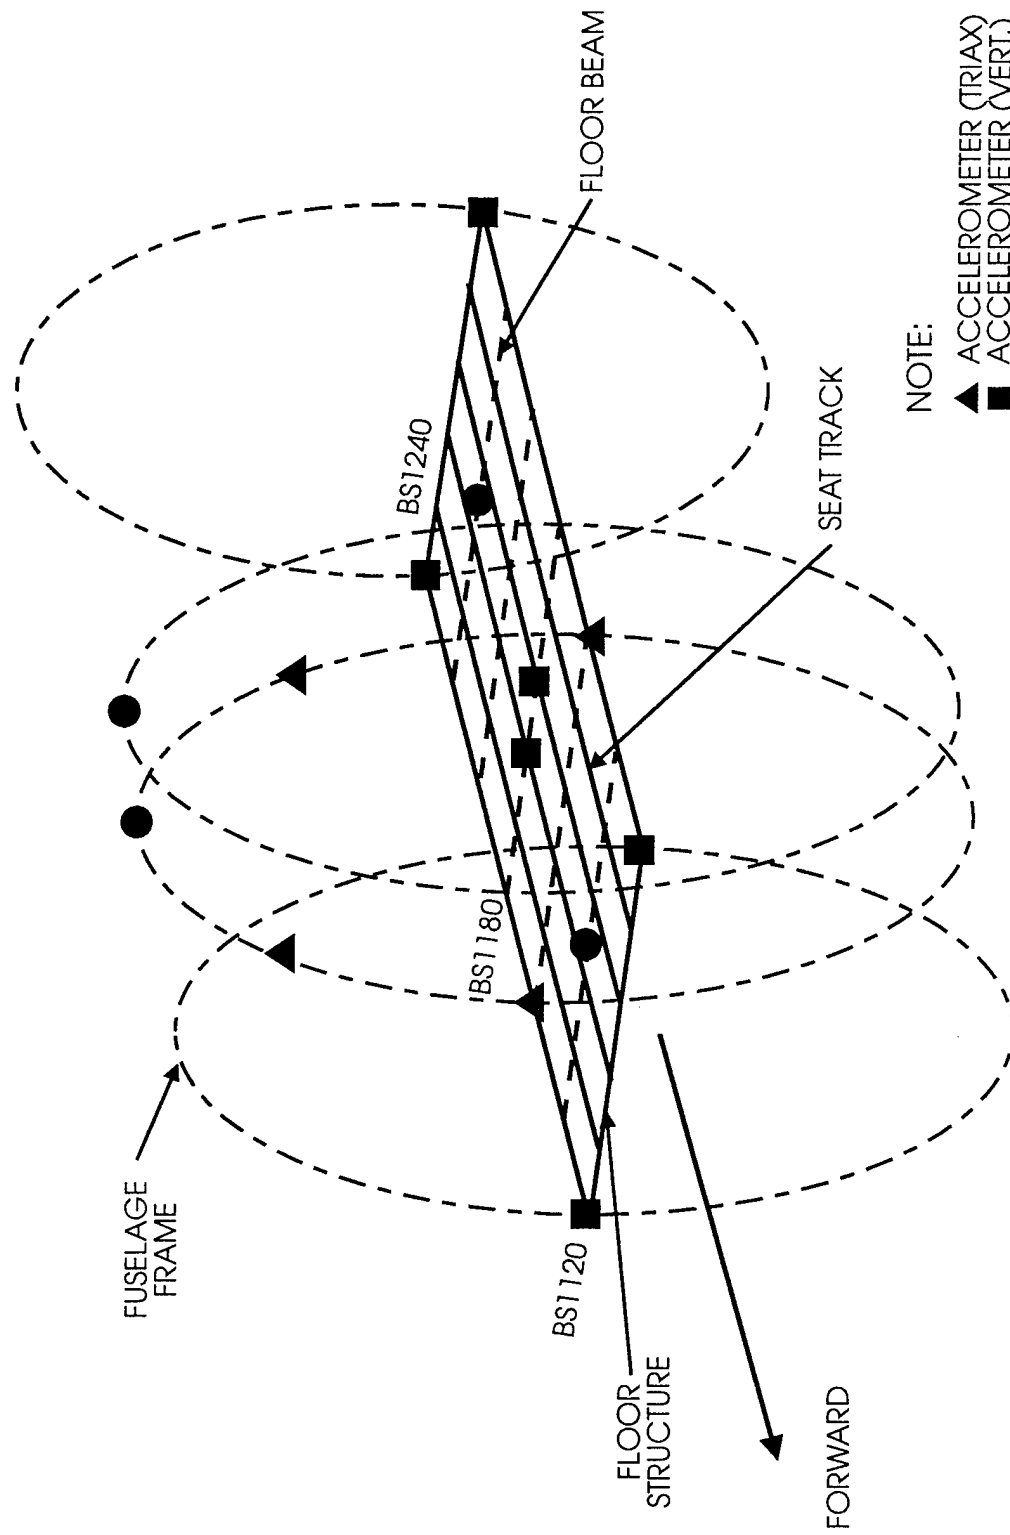
FIGURE 6. FUSELAGE MOUNTED SENSORS

As shown in figure 6, there were a total of 18 accelerometers located on the aircraft structure. Referring to the floor as  $Z=0$  and center of the front view of the fuselage as  $Y=0$ , table 4 indicates the channel number and the X-, Y-, and Z-coordinates of the accelerometers on the fuselage, as well as all the other instrumentation used in the test. The majority of the accelerometers were concentrated about BS1180, the midsection of the aircraft specimen. This area was selected because it was the approximate location of the auxiliary tank, instrumented dummies, and midsection of the overhead stowage bins. The other accelerometers were located at strategic points about the structure to assist in the test analysis. Two displacement transducers were mounted on the aircraft ceiling at BS1180, with the cable end attached to the cabin floor. Their purpose was to indicate any deformation of the floor due to the auxiliary fuel tank impacting the underside of the floor. There were also two displacement transducers mounted on the underside of the floor, with the cable attached to the bottom of the aircraft structure. These were mounted fore and aft of the auxiliary fuel tank to determine the amount of crushing of the aircraft structure. These data will be used in an FAA-sponsored program to analytically simulate testing. The accelerometers measuring structural data were recorded on channels 301-403, the transducers measuring the floor deformations were recorded on channels 429 and 430, and the transducers measuring the aircraft crushing were recorded on channels 413 and 414.

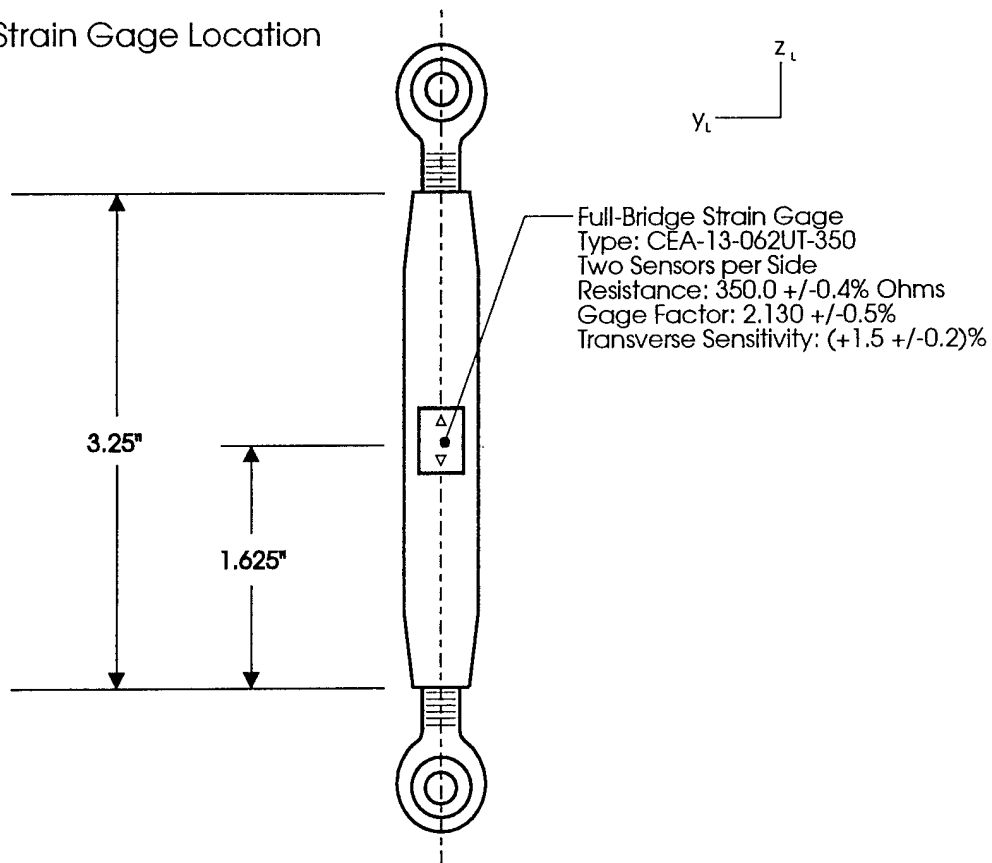
FIGURE 8. BOEING LINK: SENSOR LOCATION AND DIAGRAM

### A. Strain Gage Location

### B. Full-Bridge Diagram (Axial)

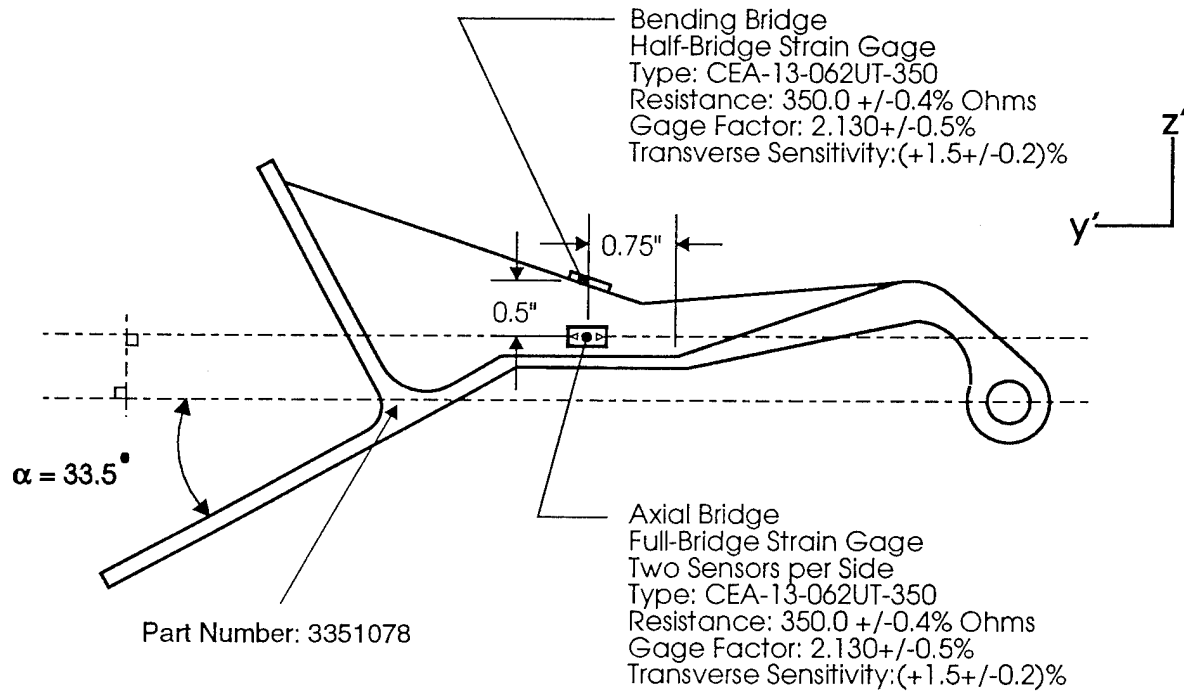
FIGURE 11. C&D LOWER FITTINGS: SENSOR LOCATIONS

### A. Strain Gage Location

### B. Half-Bridge Diagram (Bending)

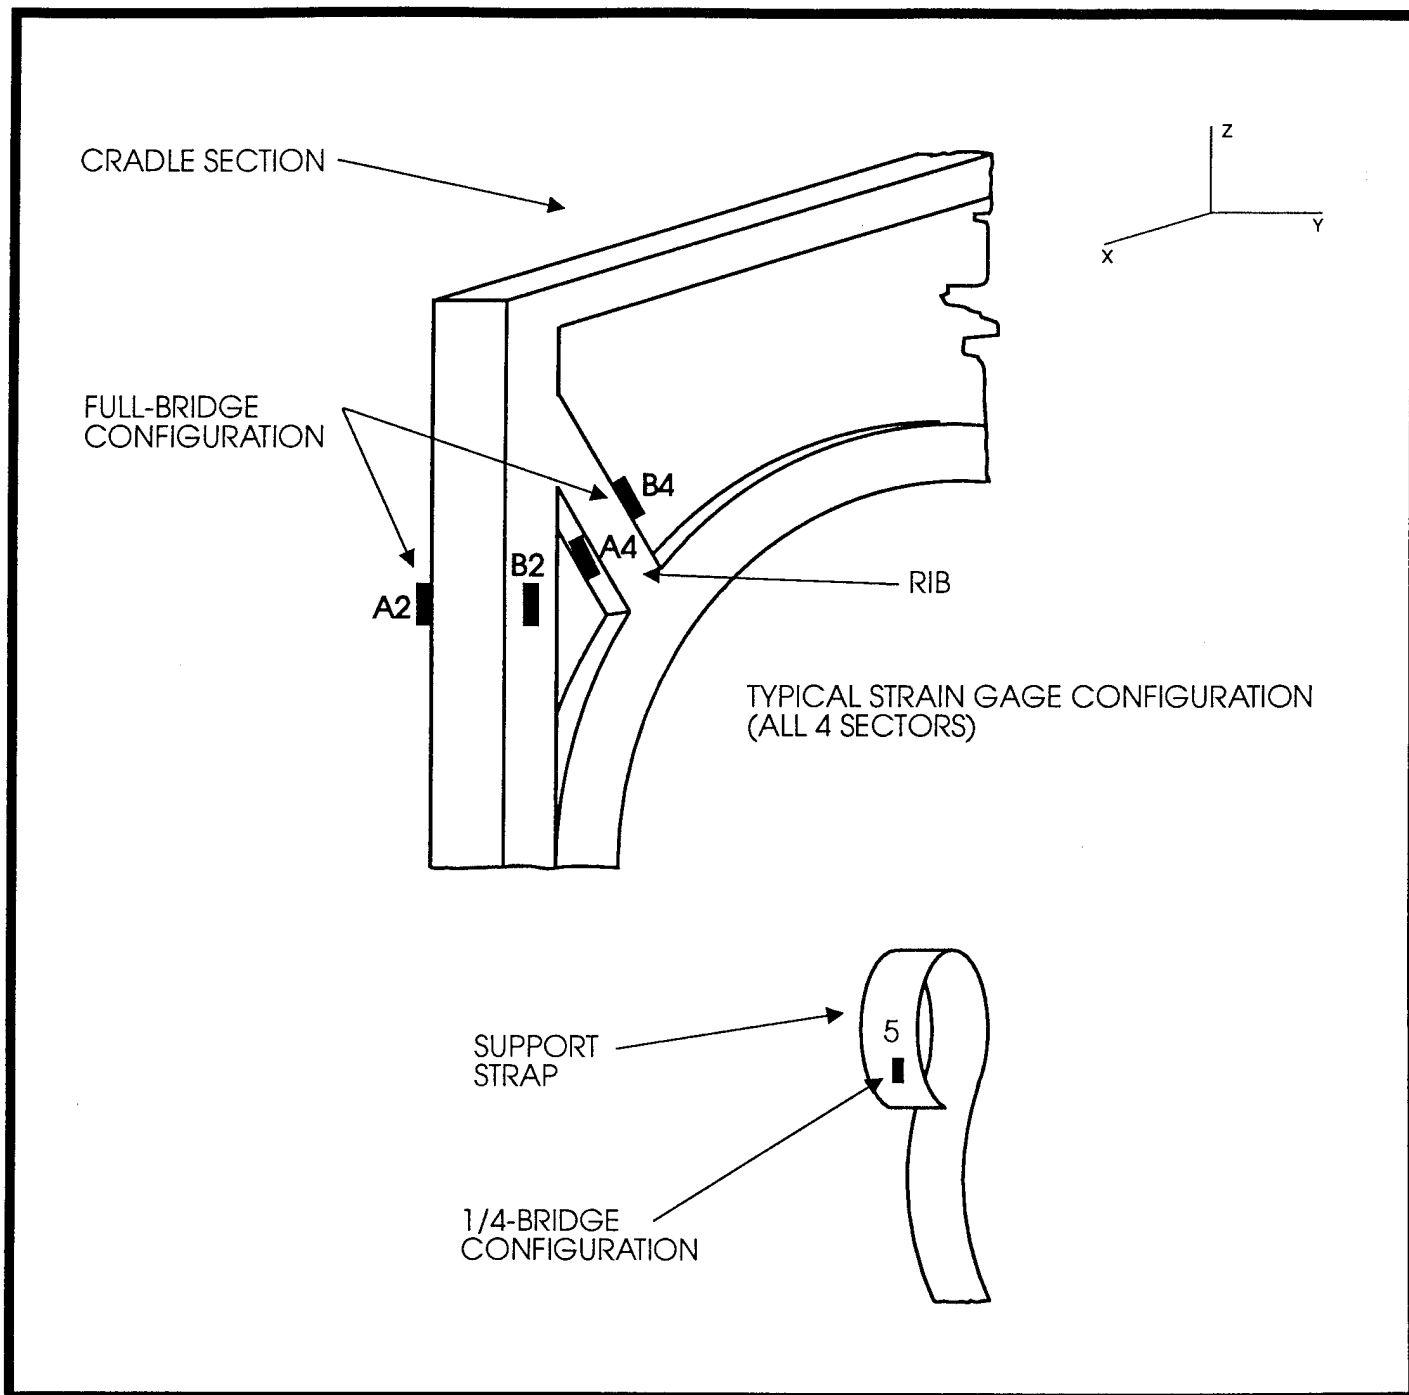
FIGURE 12. AUXILIARY FUEL TANK CRADLE: INSTRUMENTATION LOCATIONS

The auxiliary fuel tank's four upper cradle corners were strain gaged on the vertical and diagonal supports, along with the support strap, as shown in figure 12, for a total of 12 channels. All data were recorded on channels 101 to 112. Four accelerometers were attached to the cradle and recorded data in the Z-direction. Six accelerometers were attached to the tank, with four recording in the Z-direction and two in the X-direction.

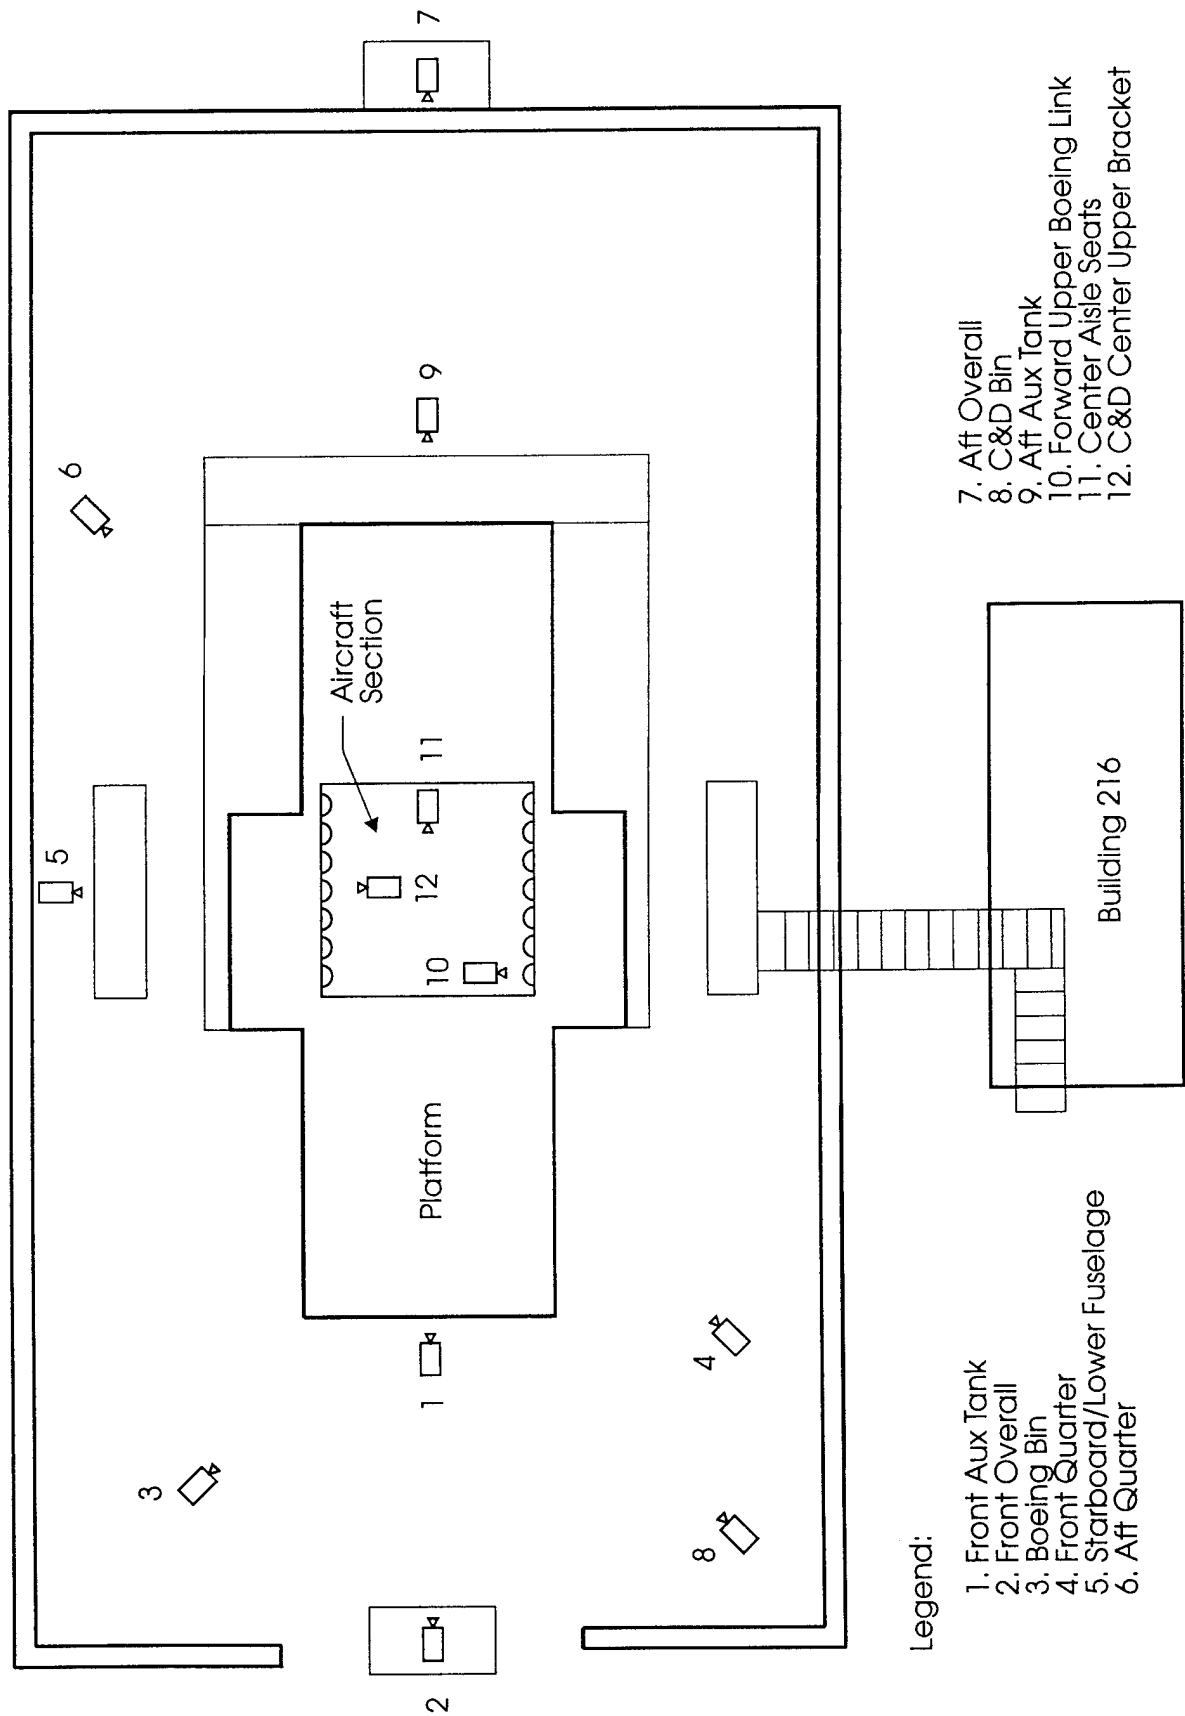
FIGURE 13. CAMERA LOCATIONS

Cameras 1 and 2 provided a front view of the auxiliary fuel tank and an overall view, respectively. Camera 3 focused on the Boeing bin and camera 4 showed a front quarter view from the left side. Camera 5 showed a lower view of the right side of the fuselage. Camera 6 was an aft quarter view from the right side while camera 7 was an aft overall view. Camera 8 focused on the C&D bin from a forward left view. Camera 9 showed an aft view of the auxiliary fuel tank.

The remaining three cameras were mounted on the fuselage. Camera 10 provided a close-up view of the forward Boeing bin support links. Camera 11 showed a view of the fuselage floor along the center aisle. Camera 12 provided a close-up view of the center upper bracket of the C&D bin.

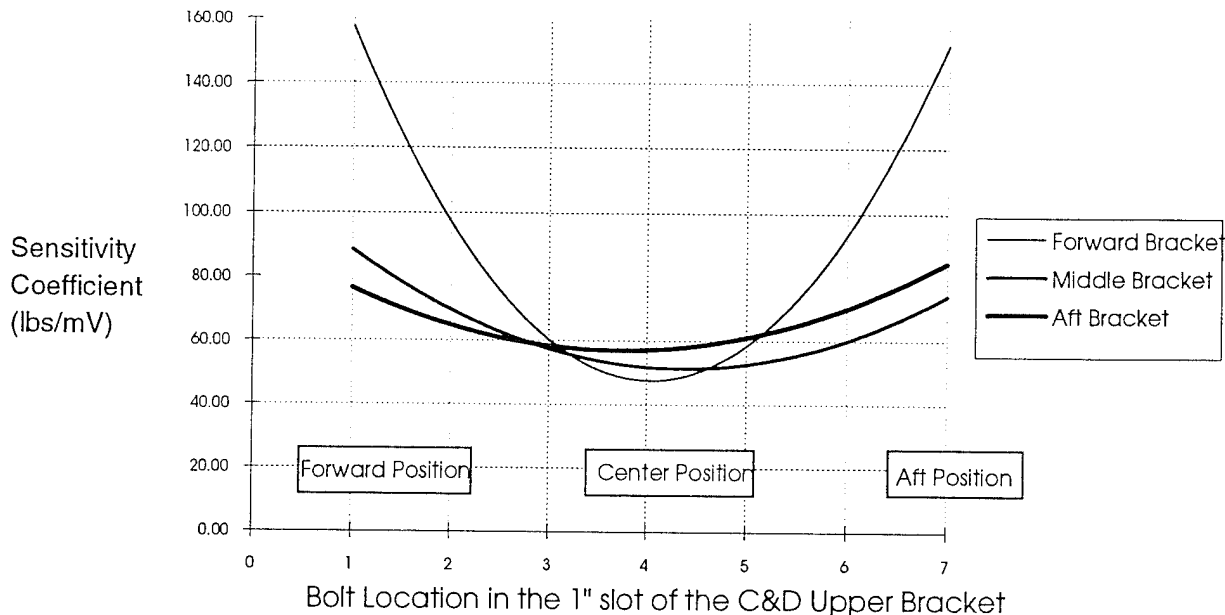
FIGURE 16. SENSITIVITY COEFFICIENT VS BOLT LOCATION

Previous attachments calibration (reference 7) indicated that the sensitivity coefficients of the bending strain gages bonded on the upper brackets were dependent on the location of the bolt in the slot (figure 16). At zero load, the forward bracket bolt was centered in the slot (location 4), and the middle and rear brackets bolts were at the end of the slot (location 7). Bolt location identifiers are presented in figure 17 and the C&D upper bracket's installation angles are shown in figure 18.

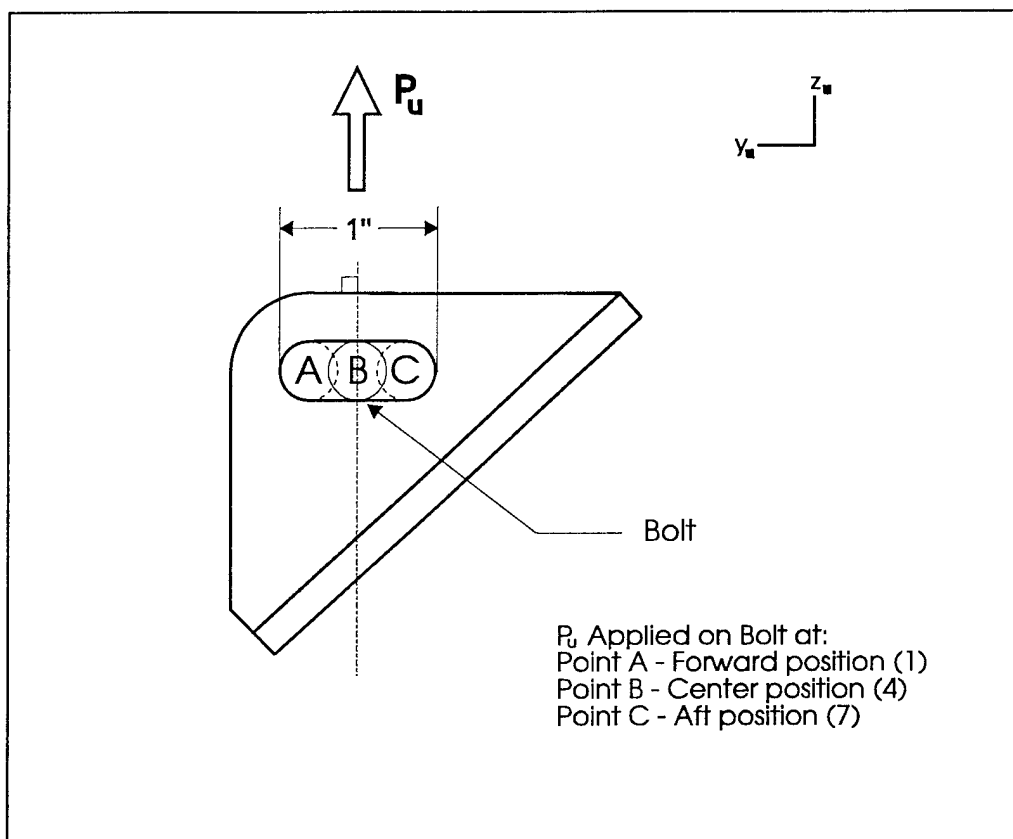
FIGURE 17 . BOLT LOCATION IDENTIFIERS (UPPER BRACKET)

Before the calibrations were done, the exact location of the bolt, in the one-inch slot of the upper bracket, was determined (figure 17). In addition, the installation angles were measured. These measurements were repeated after each weight increment.

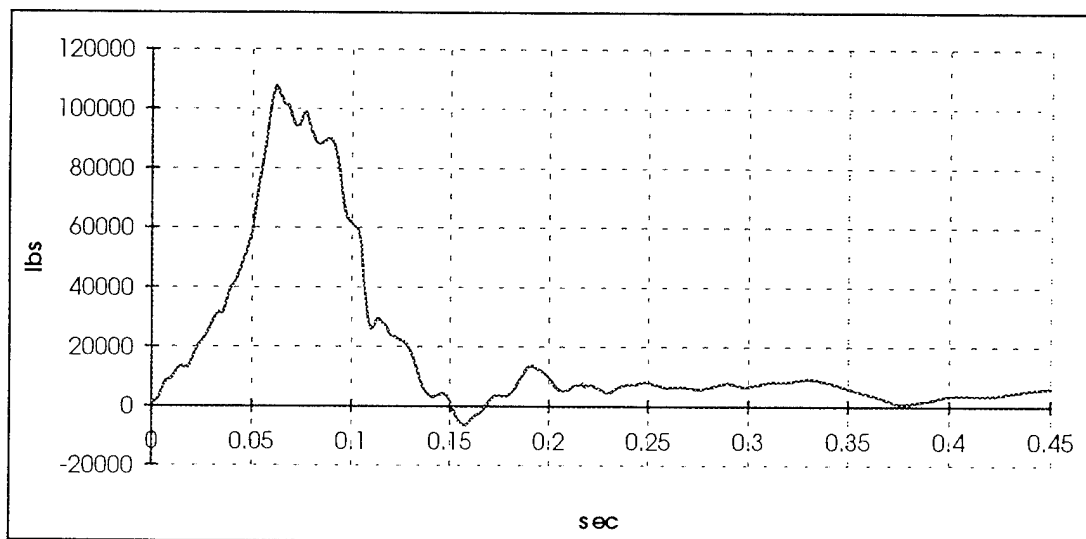
FIGURE 22. PLATFORM TOTAL LOAD

The platform was supported by 12 load cells to measure the impact load. One platform load cell located at the mid-aft left side exceeded the full-scale load limit (33,500 lbs) at 57 milliseconds after impact. One load cell located at the mid-forward right side failed. Comparing the measured loads based on locations and sides, which are symmetric, it is reasonable to assume that a load cell on the left side measured the equivalent load as one on the opposite side (right side) at a same longitudinal location, i.e., forward or aft. In this case, the maximum platform total load during the primary impact was approximately 107,000 lbs. The platform load data is presented in figure 22.

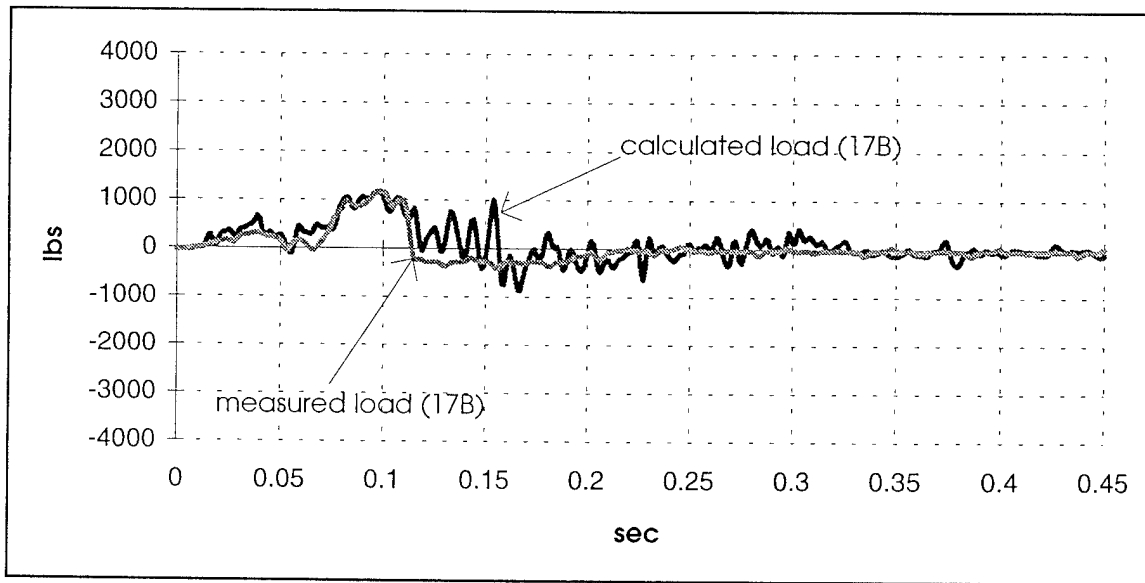
FIGURE 23: BOEING LINK 17B LOAD COMPARISON

The maximum measured loads on each link during the initial impact, the primary impact, and after the primary impact are shown in table 28. These loads were not the cause of the link fractures. Some links failed due to bending and shearing forces which occurred when the bins shifted fore and aft after the impact, due to fuselage section pitching, as evidenced from film analysis.

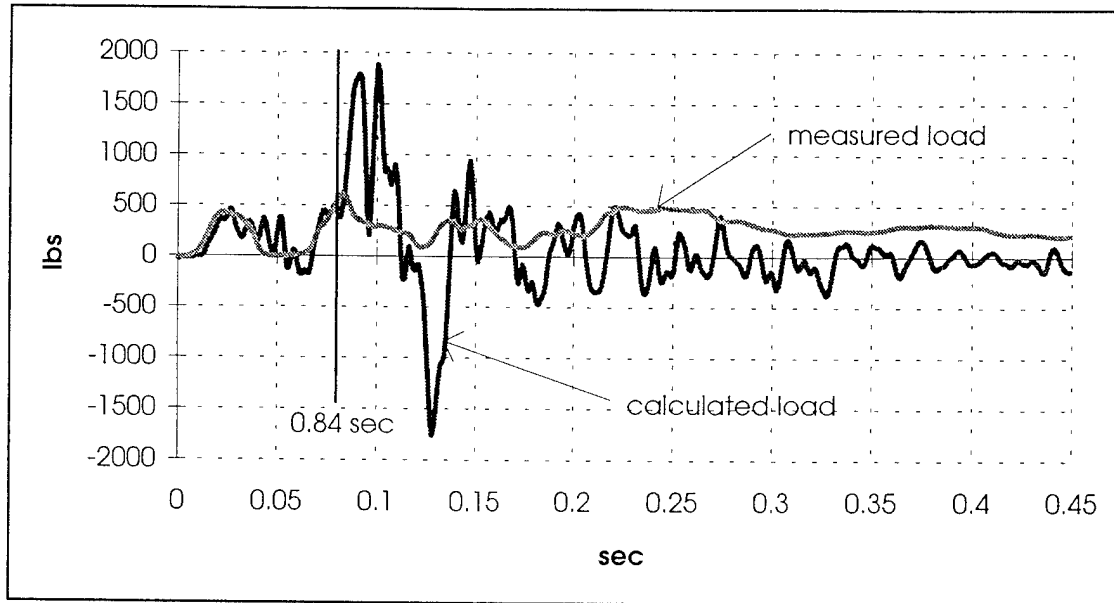
FIGURE 27: FORWARD UPPER BRACKET LOAD COMPARISON

Figures 27-29 illustrate the comparison between measured and calculated loads for the brackets. Figure 30 shows the total vertical load of the C&D bin.

Comparisons of the measured loads and the calculated loads are only valid for the first 0.084 second, because at that time the aft upper bracket disbonded from the bin.

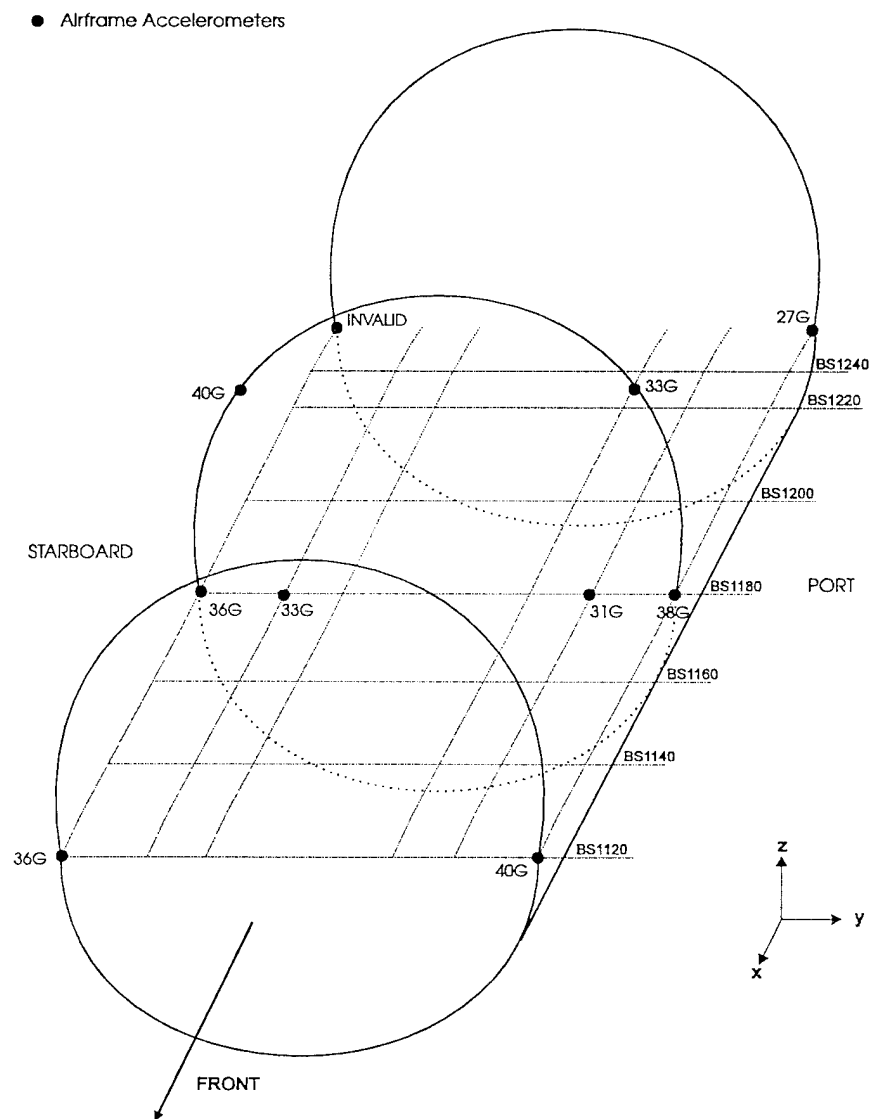
FIGURE 31. ACCELEROMETER LOCATIONS AND  $G_{\max}$  VALUES OF THE FUSELAGE

For better readability and understanding of the deceleration level of the test, the overall diagrams of the accelerometer locations and their associated  $G_{\max}$  values are shown in figures 31 and 32.

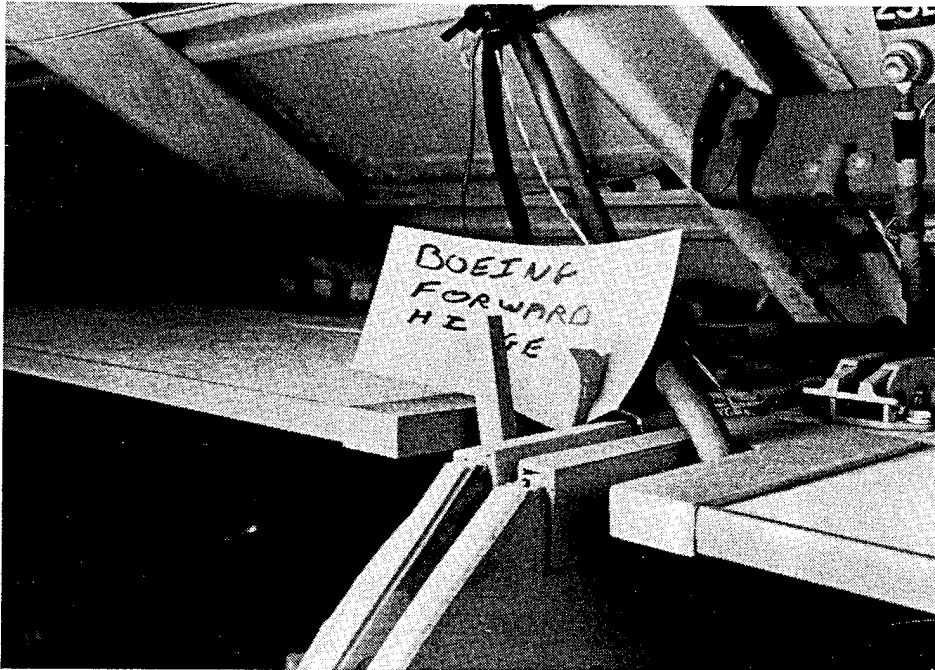
FIGURE 43. BOEING BIN BROKEN FORWARD HINGE, POSTTEST

- a. The personal service units (PSUs) detached from the bin prior to the primary impact pulse.
- b. Both door hinges fractured. The contents in the center compartment did not spill due to the plastic strap, which was added for this test, placed around the door and bin.
- c. Five support links, out of a total of 15 links, were damaged after the primary impact pulse. Four links were broken, two instrumented (17B and 28B) and two noninstrumented (one placed on the bottom of the bin at BS1145 and

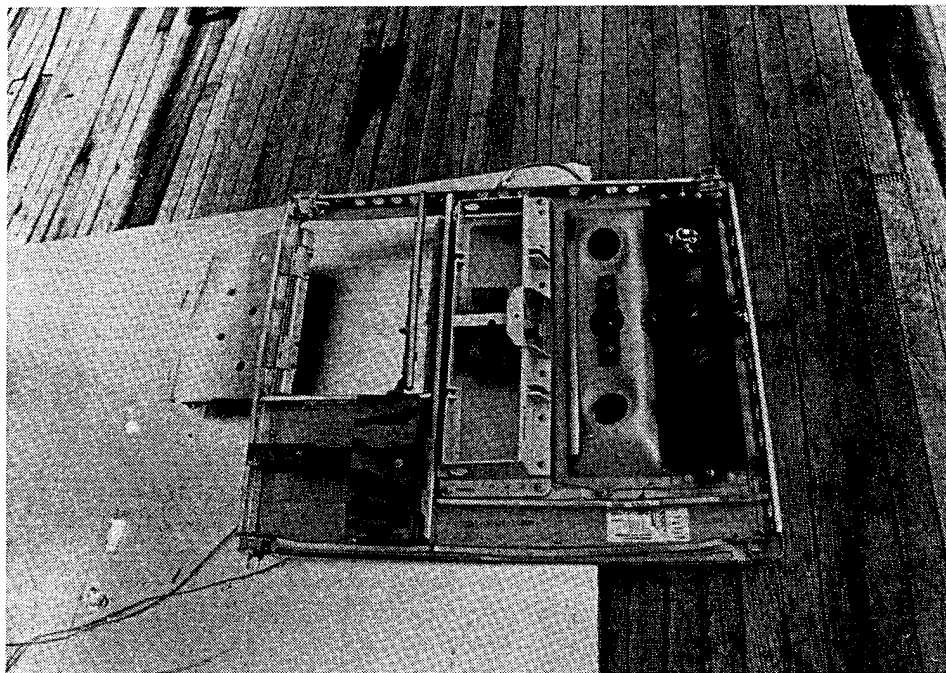
FIGURE 45. PSU UNIT AFTER SEPARATION, POSTTEST

The passenger service units (PSU) attached to the Boeing bin came loose primarily due to the relative motion between the bin and the fuselage. The PSUs were attached to both the bin and the fuselage side wall.
